The 1903 Brandon Bridge Collapse

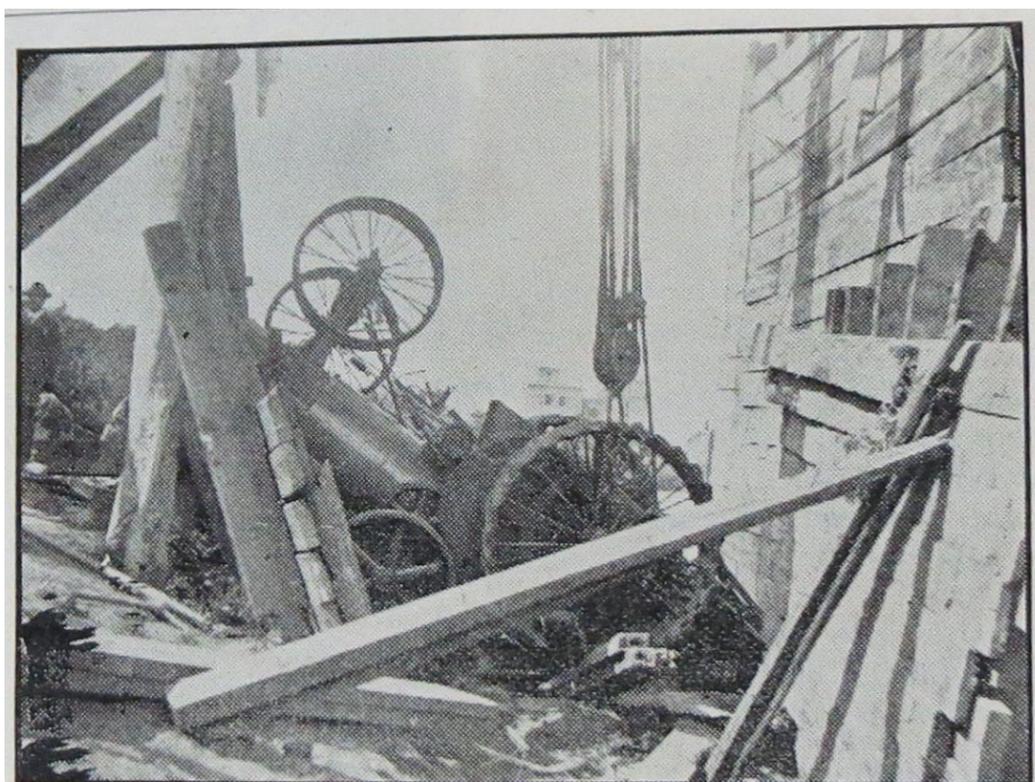
On September 4, 1903 the wooden approach to the First Street Bridge gave way as a new Port Huron steam engine was moving across the approach to get onto the actual bridge span across the Assiniboine River. The engine fell some 20 feet to the river bank below, landing upside down. Tragically the operators, William Curle and Richard Chambers, lost their lives in this accident as they were caught beneath the engine. William Curle farmed in the Justice, Manitoba area. Richard Chambers was an employee of the Brandon agent for the Port Huron Company.

Soon after the accident, William Curle's sons retrieved the engine. An attached photo shows the engine upside down under the bridge with a heavy rope fall (block and tackle) hanging above the engine. Today with modern cranes, backhoes and bulldozers this job would be a morning's work. In the Pioneer era when all the Curle brothers may have had was access to heavy timbers, a heavy rope fall and perhaps a couple of heavy jacks, righting this engine would have been a daunting task. Close examination of the image indicates that the rope fall was being attached to the center of the rear wheel visible and, if so, it appears that they were going to roll the engine over on to its side and then roll it on to its wheels. Once on its wheels it would have been relatively easy to move the engine up the river bank. In this case the rope fall was probably attached above the engine to heavy timbers running between the bridge pier visible on the right and timber piles visible on the left. One question is whether the Curle brothers were using teams of horses to pull on the free end of the rope fall or whether they had a winch of some sort. Unfortunately the photo does not show details of how the rope fall was operated.

THE ENGINE LYING BOTTOM UPWARDS UNDER BRIDGE.

Bridge collapses caused by a steam engine moving over the bridge were a not uncommon occurrence in the Pioneer era. There were a variety of reasons for these collapses. Treated or creosoted timbers were not commonly used at the time in municipal bridges leading to rapid deterioration of bridges. However the chief cause was that many bridges were built too lightly for steam engines which were rapidly evolving. Farmers wanted more power which in turn meant steam engines became bigger and heavier. Many bridges built previous to 1900 were built with the idea that they would carry nothing heavier than a loaded grain wagon. Grain wagons at the time usually carried around 30 bushels of wheat or approximately 1800 pounds with perhaps the wagon weighing another 1000 pounds along with a team that, depending on the breed of horses used, may weigh another 2000 pounds for a total weight around 5000 pounds. Steam engines rapidly exceeded this weight between the metal in the machine and the necessary fuel and water that the engine had to carry. So moving engines over bridges was always fraught with the danger that the bridge would give way. There are reports from this time that a custom thresher at Chater, Manitoba just east of Brandon always moved to a custom job just north of Brandon by railing his equipment on the CPR branch line that used to run from Chater to Minnedosa via Forrest, Manitoba. The line ran close enough to the farm they were going to and there were handy loading docks to load and unload machinery. Of course in those days, railways were more accommodating to local traffic. But the use of the branch line indicates the issues involved in moving steam engines around the countryside.

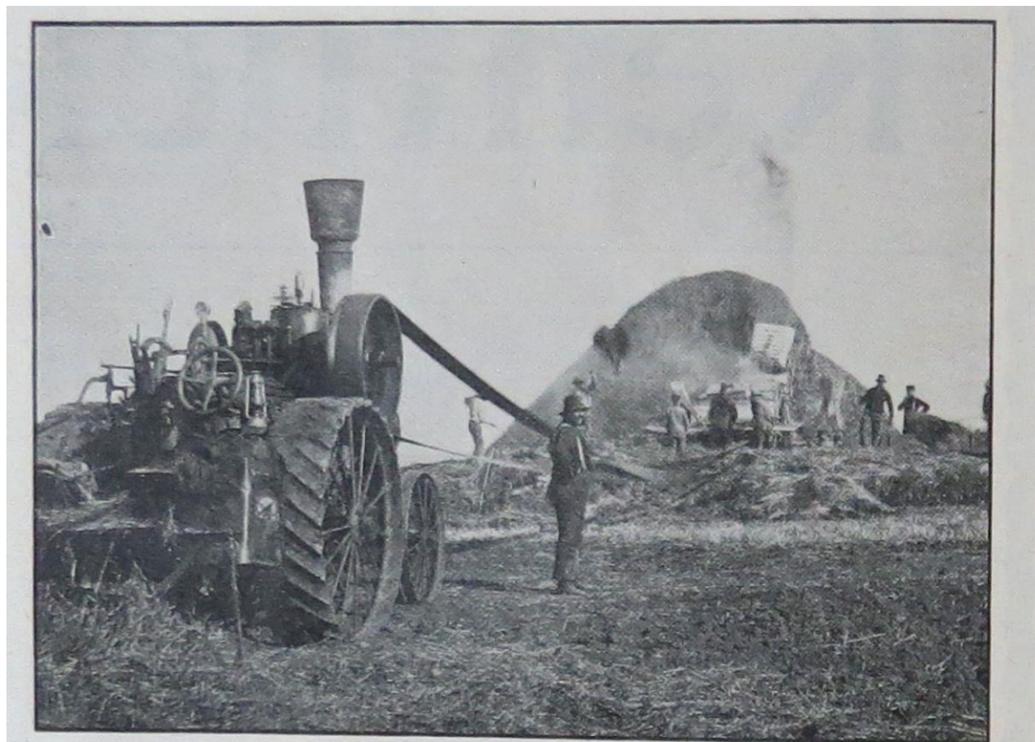
However the Curle Brothers managed to do it, they retrieved the engine and made the necessary repairs to it which cost the grand sum of \$67 according to reports at the time. One of the images accompanying this release shows the engine at work threshing later in the fall of 1903. This image is interesting by itself as it appears that the Curles were threshing from stacks as there are sheaves piled on the ground ahead of the thresher and no sheaf wagons are visible. As no snow is visible on the ground one wonders what changed as it was less work to feed the sheaves into the thresher as the wagons hauled them in. Stacking the sheaves was usually done when bin space ran out and the grain handling system had no space for further deliveries. Sheaves were then stacked to protect them from the weather. In this time period, the grain handling system rapidly became "plugged" at harvest due to the rapid expansion of acres under cultivation. As grain movement to the east largely stopped when the Great Lakes froze over, sheave stacks were normally threshed in the spring when movement resumed. The thresher does not appear to have a self-feeder but rather a table on which the sheaves were forked and then pushed into the machine by hand after the twine was cut. The machine also appears to have an apron stacker but yet the straw pile is higher than the stacker. As apron stackers did not throw the straw too far, how the straw pile got so high would be interesting to determine.

THE SAME ENGINE AT WORK AFTER THE ACCIDENT.
